IP Flush Master & Handset Compatibility

Configuration Guide

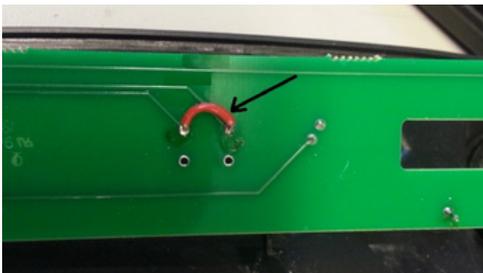
The handset has to be first upgraded to revision 0300 by doing the following:

When handset revision 1008097100.0201 or earlier is used with IP Flush Master revision 1008031000.0301 or earlier, one may experience noise in the earpiece of the handset. This problem can be rectified by upgrading the handset to revision 1008097100.0300 and using the headset connector of the station.

- Dismantle the handset by removing the two screws on it
- Flip the circuit board over and solder a strap as shown below

- Dismantle the handset by removing the two screws on it
- Flip the circuit board over and solder a strap as shown in section 3.2
- Upgrade the software of the IP Flush Master to version 02.3.3.1 or later
- Log on to the Station Web
- Select **Advanced AlphaCom > Audio**, and enable the option **Handset in Headset Slot** as shown in section 2.2
- Connect the handset to the HEADSET connector of the station.
